BUKU-KAPATI HYDROPOWER PROJECT - 5 MW

PHYSICAL PROGRESS REPORT

2081 Magh

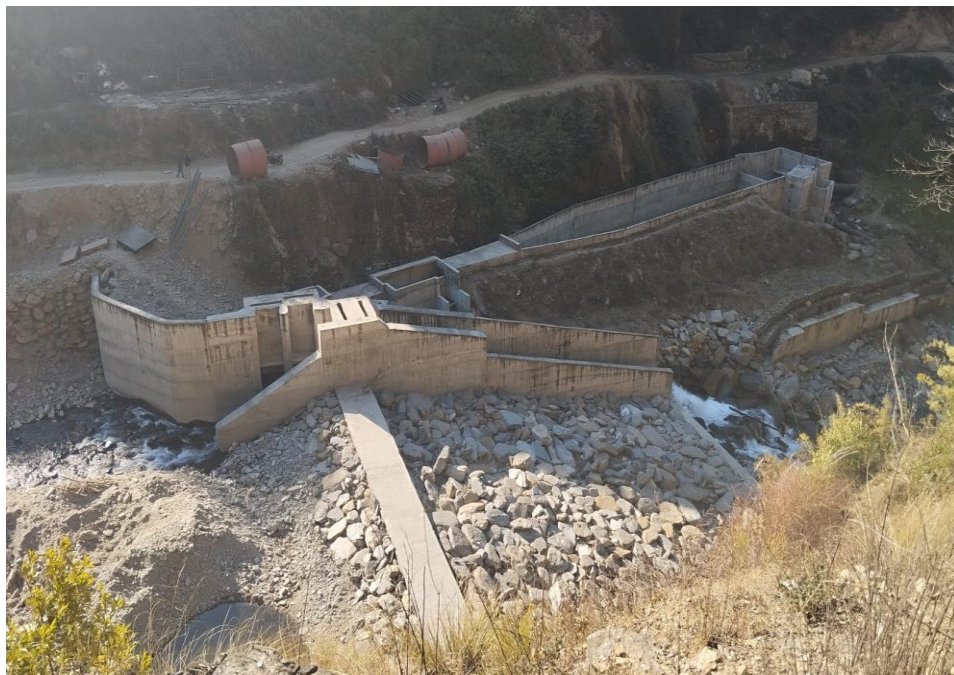
Figure 6-1: Figure 6 1: Head Works Structure

Status: 95% Completed.

Description: The headworks include diversion weir, under sluice, intake & gravel trap, approach canal and settling basin.

Remaining Work: Installation of hydro-mechanical gates and additional protection

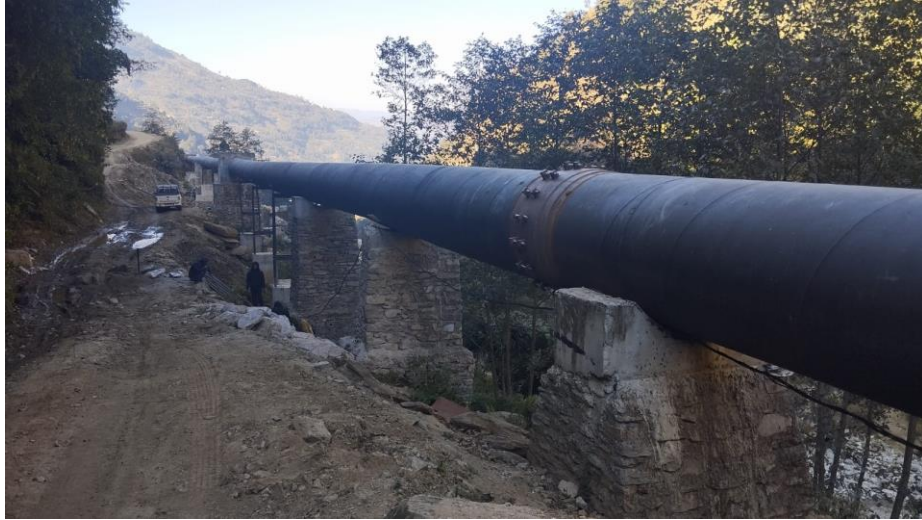
Figure 7-1: Head Race Pipe Erection.

Status: 97% of the work is completed. Out of the total 1,925 meters of headrace pipe, only 6 meters remain to be installed.

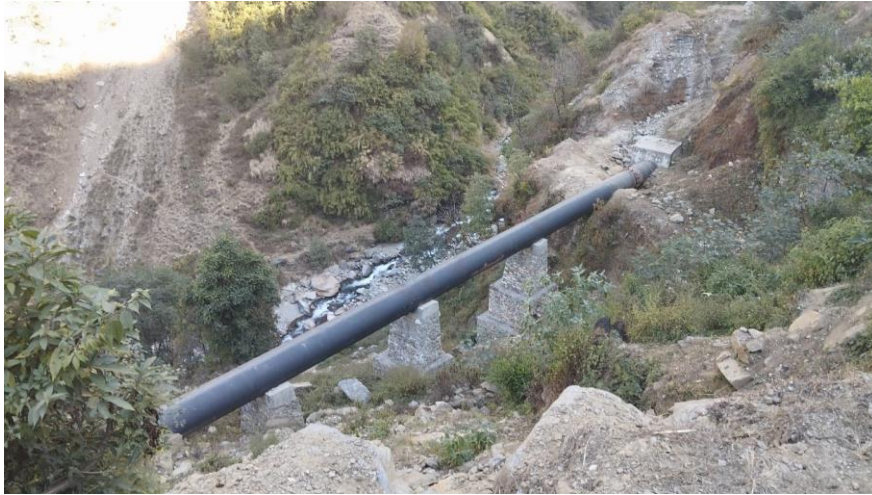
Figure 7-3: Stone Masonry Saddle Support.

- Repair work of saddle support 2 (damaged by landslide) from AB-3.

- Workmanship and design consideration of repair works of saddle supports.
- Coordination among contractors and suppliers is critical to overcome delays.
- **Outlook:** The project is advancing steadily, with the overall weighted progress indicating significant milestones achieved. However, some delays in civil and HM works need to be addressed to meet project timelines.

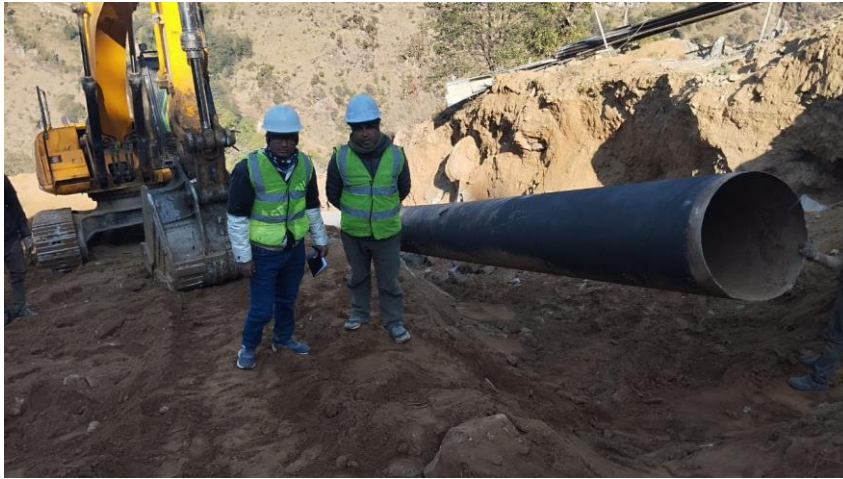
Figure 8-1: Surge Shaft.

Status: 90% Completed.

- Installation of surge shaft pipe works (Horizontal-36m, Inclined-30m) is remaining
- Installation of 72m penstock pipe is remaining.

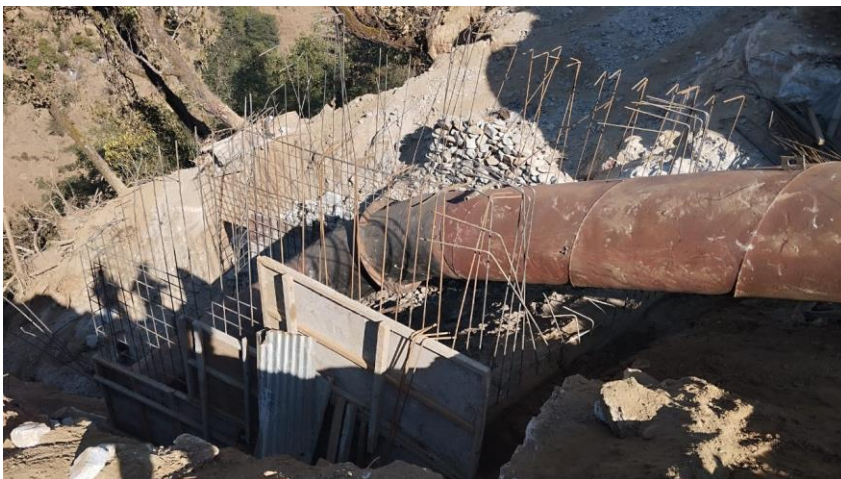
Figure 8-2: Anchor Block (AB-31).

- Fabrication works completed
- Excavation work in progress.
- Rebar works of AB31 and AB31A is going on.

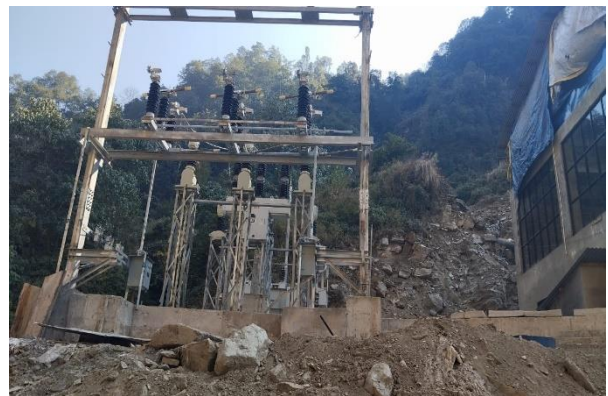
Figure 9-1: Switchyard

- Construction of the powerhouse superstructure and switchyard is completed.
